## **SIDEWALKS/ADA RAMP INVENTORY & CONDITION ASSESSMENTS**

**LOCATE - ATTRIBUTE - ASSESS - PLAN AHEAD**

Zac Thomason, M.B.A  
National Client Services Manager

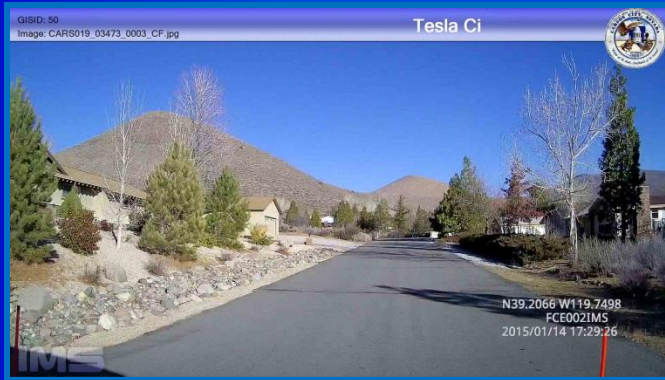
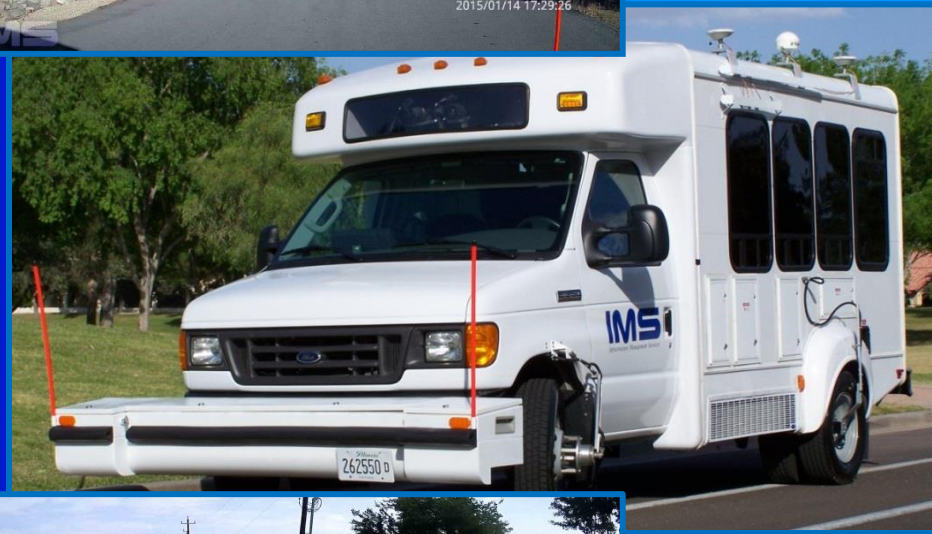
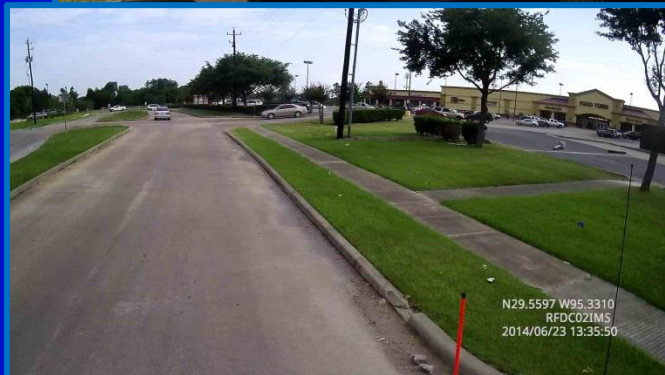
**Laser Road Surface Tester (RST)**

*Automated pavement distress data  
GPS & multi-view HD RST video*

**1 pass locals & 2 pass arterials/collectors**

*Rear facing camera for adjacent ROW*

**Deliverable – 25 foot intervals**

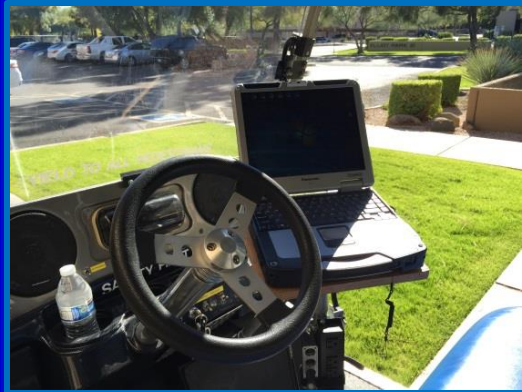
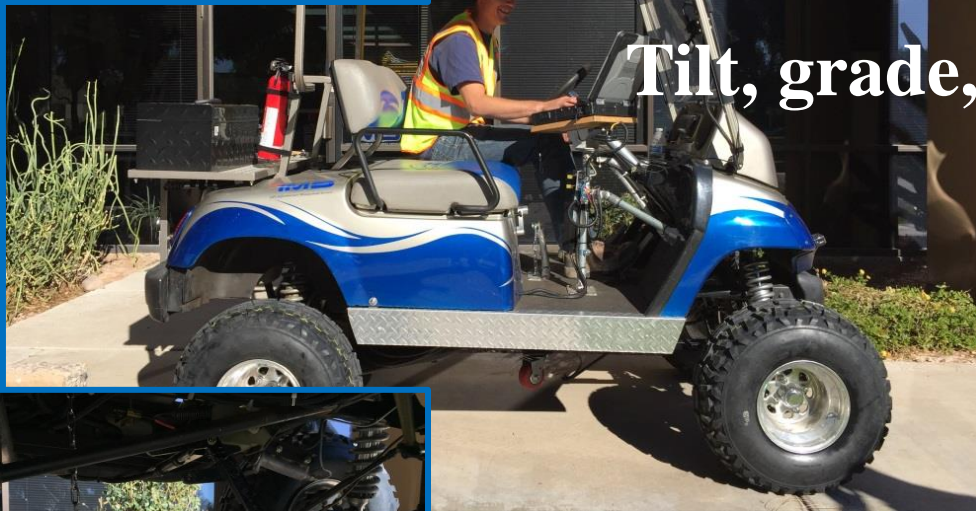
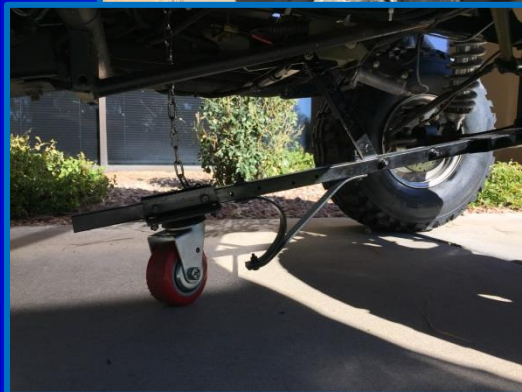
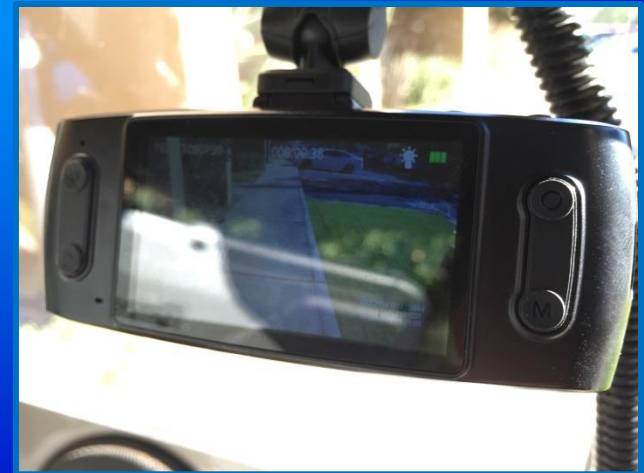
**Modified gas powered golf cart**  
**Nomad survey application**  
**GPS & E-Prance HD cameras**  
**Distress observations**  
**Tilt, grade, & adjustable fault meter**  
**Climbs 8" curbs**

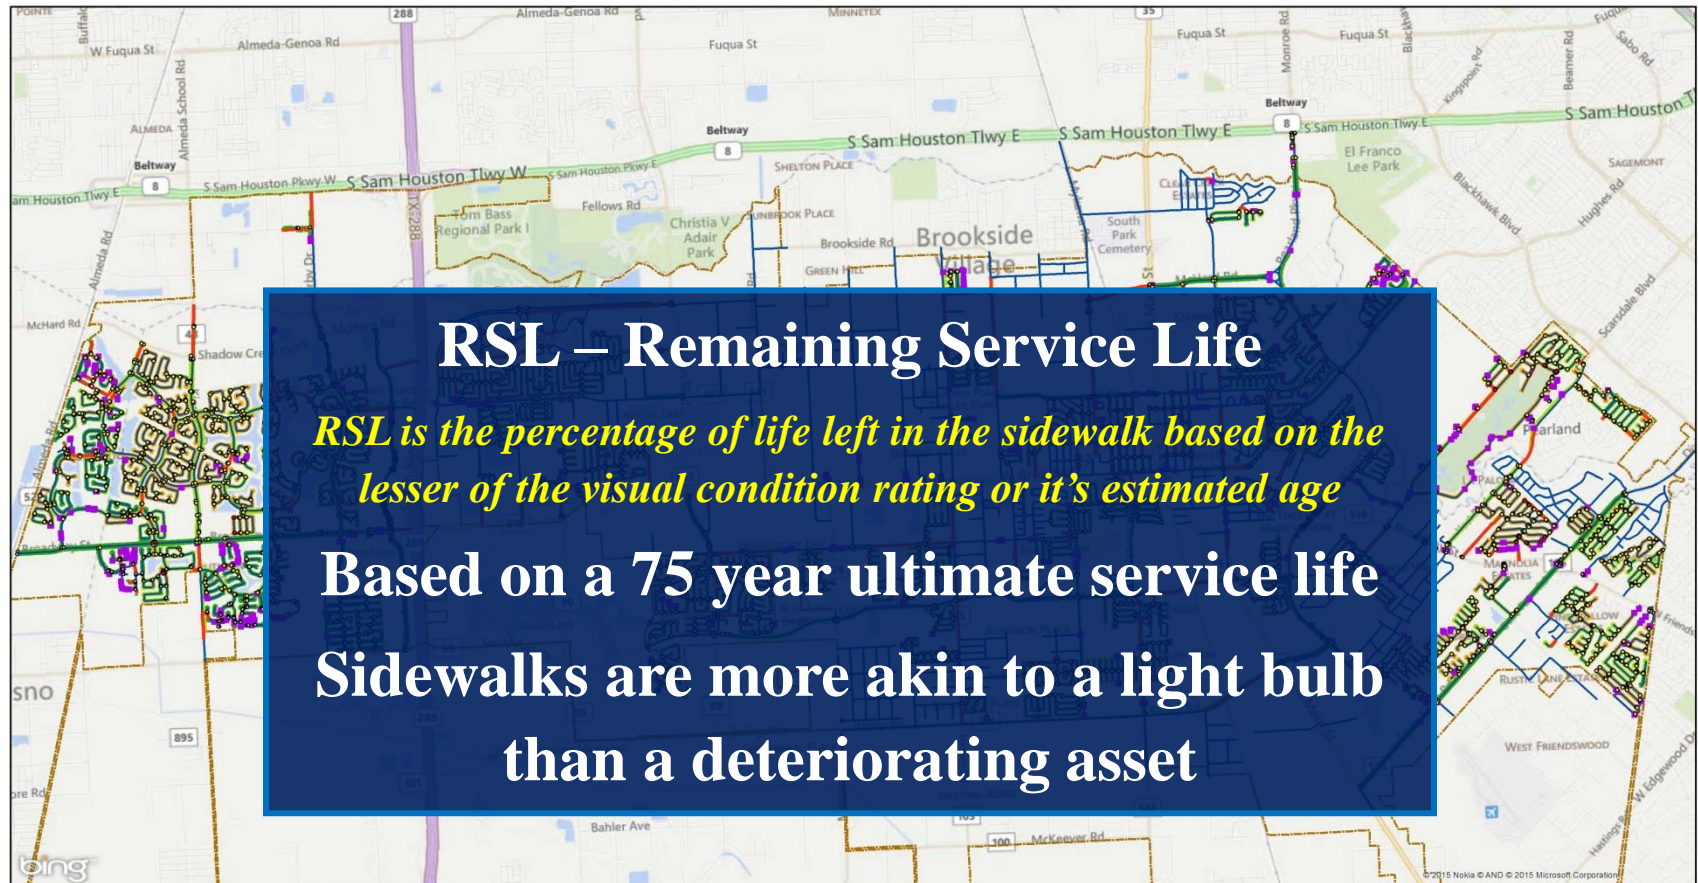
## RSL – Remaining Service Life

*RSL is the percentage of life left in the sidewalk based on the lesser of the visual condition rating or it's estimated age*

Based on a 75 year ultimate service life  
Sidewalks are more akin to a light bulb  
than a deteriorating asset

- Very Good (80 to 100% RSL)
- Good (60 to 80% RSL)
- Fair (40 to 60% RSL)
- Poor (20 to 40% RSL)

Based on a 75 year ultimate service life,  
the RSL is the percentage of life left in the sidewalk based on  
the lesser of the visual condition rating of the sidewalks  
or its estimated age.

RSL – Remaining Service Life based on a 75 year average service life and the percentage of the visual condition of the sidewalk or its surface.
